2nd Department of Radiology, Medical University of Lublin

Ultrasound appearance of the silicone breast implants: two cases of implants margins folding

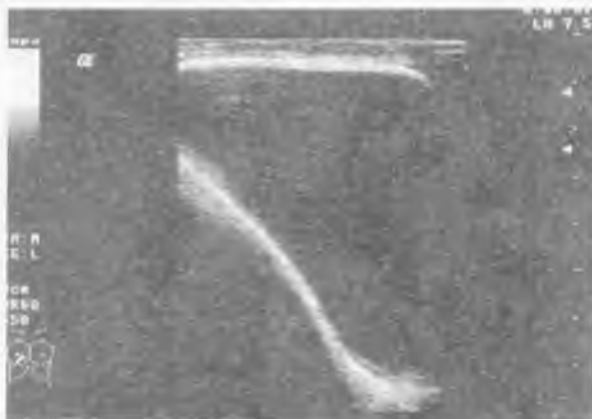
Fig. 1. Normal image of silicone breast implant. Hipocochoic silicone inside the hiperechoic capsule

The normal sonographic appearance is a triangular-shaped anechoic structure (Fig. 1) with a striking reverberation band anteriorly in the near field. Anterior to the implant is an echogenic line of variable thickness that represents the elastomer shell and the fibrous capsule (6). The margins of the capsule are regular, smooth.

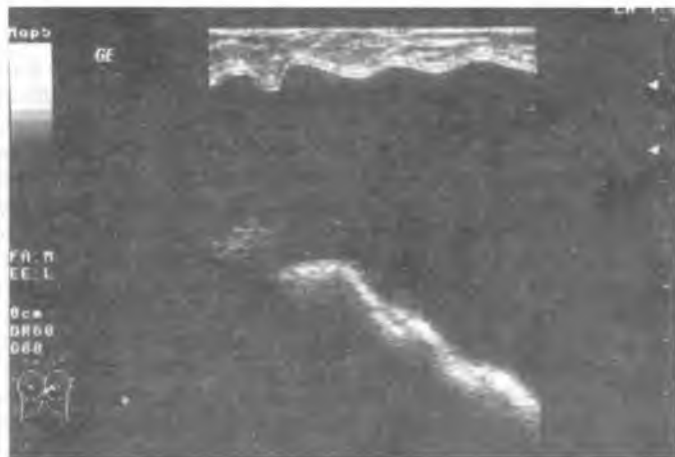
Eight years after implantation of silicone breast implants due to cosmetic reasons, a 31-year-old woman came to see a doctor because of palpable irregularity in the surface of the implants. The irregularity of the implants appeared 3 months before examination, and the patient was seriously frightened by the findings. The ultrasonography revealed the mild folding of external margins of the implant, and on the wall adjacent to the chest (Fig. 2). No other implant pathology was revealed.

Fig. 2. Folding of the anterior and posterior wall of the implant capsule

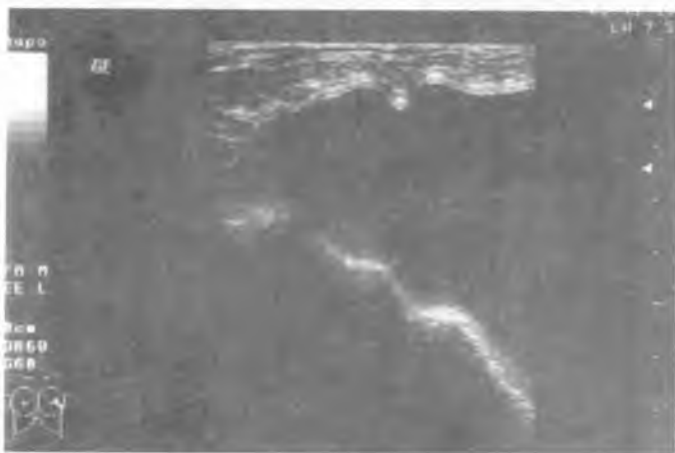
Fig. 3. Folding of the silicone implant margin

Three months after implantation of the silicone breast implants due to cosmetic reasons, a 27-year-old woman reported for control examination after implantation. The folding of the implant margins were found, especially on the lateral margin (Fig. 3). The folds were not palpable, and the patient was not aware of their presence.
