ANNALES UNIVERSITATIS MARIAE CURIE-SKŁODOWSKA LUBLIN-POLONIA

IZABELLA DUNIN-WILCZYŃSKA, BARBARA JĘDRYCH, BARBARA JĘDRYCH-GÓRSKA, HENRYK SKRZYPEK

Fused tooth in scanning electron microscope

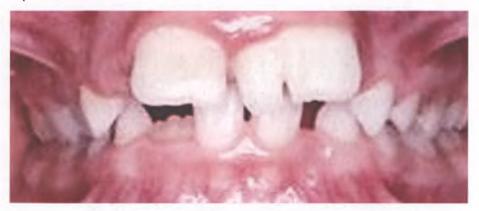
Fig. 1. Fused left central maxillary incisor impairs esthetics

The clinical and radiological examination revealed an atypical structure of a left central incisor (Fig. 1). The measurement test showed that the tooth's width was 14.8 mm. It was composed of the smaller mesial part (6.1 mm) and the larger distal one (10.9 mm) located at an angle each to the other. The sum of crown widths of two parts was greater than the measurement of the entire crown width due to the eminence of the enamel on the border of the junction, which added to the transverse measure of the crown. DPT and periapical radiograph did not prove helpful in determining the inner structure of the tooth because of rotations of components. Superimposed

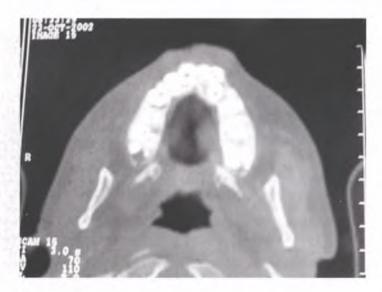
Fig. 2. ACT scan of the fused tooth in the horizontal plane

shadows of the lateral incisor made it difficult to interpret radiographs. Only CT showed that the tooth had a common chamber and two root canals (Fig. 2). Staining one half of the fused tooth with 3% aniline blue confirmed the presence of one common chamber and two root canals (Fig. 3). An examination of the tooth under a scanning microscope revealed differences in the structure in comparison with a normal tooth.

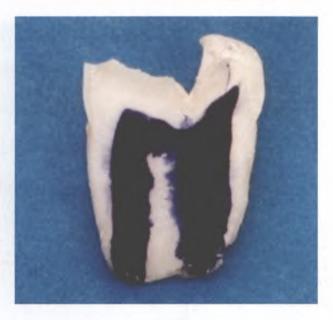
Fig.3. Staining of the tooth section with 3% aniline blue

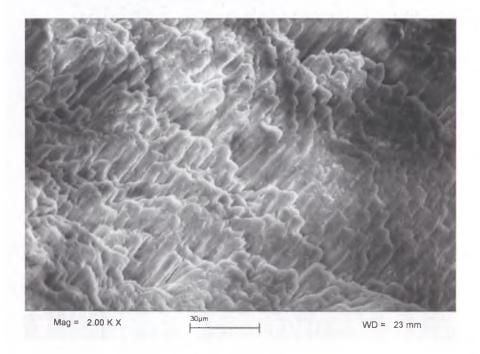
Enamel of the tooth with a normal structure consisted of tightly packed hexagonal prisms of enamel with the diameter ranging from 4 to 8 µm. Enamel prisms were situated parallel and were winding one round another in the vicinity of dentine. Each prism of enamel ran through the whole enamel layer, except the thick peri-dentinal layer and the tooth neck area. The narrow spaces between adjacent prisms were occupied by interprismatic spaces (5) (Fig. 4A).

Fig. 4A. Enamel structure of a typical tooth

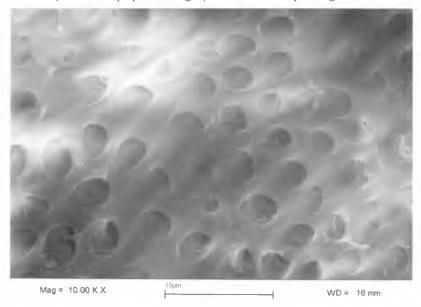
Dentine in a healthy tooth was composed of intertubular and peritubular dentine and regularly spaced microscopic dentinal tubules. Lumen of the tubules was generally round, their diameter ranged from 3-5 μ m with the pulp measuring 1 μ m in the external part (Fig. 4B).

Fig. 4B. Dentine of a healthy tooth

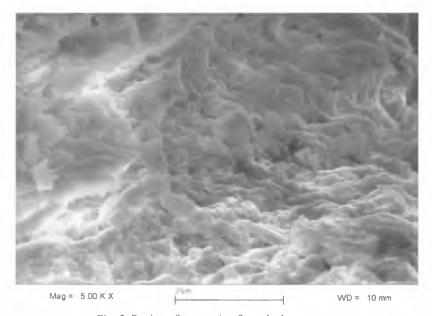
Fig. 5. Region of connection from the larger aspect

a normal structure. The prisms were situated parallel. The diameter of prisms was about 4 μ m. The interprismatic spaces showed uniform width. Enamel of the fusion area on the side of the smaller fragment presented a regular prismatic structure. The majority of the prisms ran parallel and the rest slanted. The prisms were 4.4 μ m thick. The fusion area on the side of the larger fragment revealed abnormalities in the structure of prisms. Structures with an irregular, winding course resembled bundles of enamel (Fig. 5). In the chamber dentine of the smaller part the arrangement of tubules was not regular. The majority of the tubules showed a curved course in different directions. Individual tubules presented unmineralised dentine in their initial segment. The diameter of the tubules was 2 to 3 μ m (Fig. 6A). The surface of intertubular dentine was rough and creased. Dentine in the coronal region of the larger tooth fragment presented an arrangement of regularly spaced tubules. The diameter of initial segments of the tubules was about 2.1 μ m (Fig. 6B). The direction of tubules was uniform. Intertubular dentine was delicately undulating. Dentine in the coronal part of the fusion area presented a less regular arrangement than in a normal tooth. The initial segments of the tubules revealed apparent unmineralized dentine. The diameter of the tubules was about 2.8 μ m. Intertubular dentine was delicately creased.

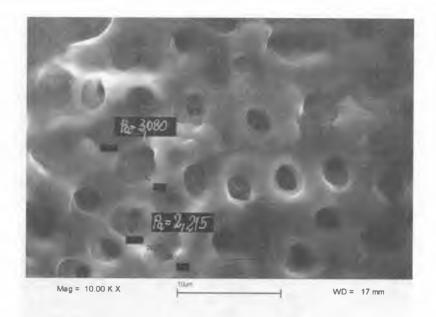
Fig. 6A. Coronal dentine of the smaller part

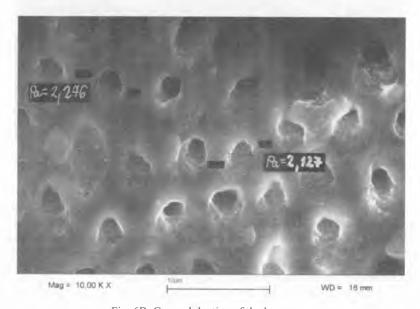
Fig. 6B. Coronal dentine of the larger part

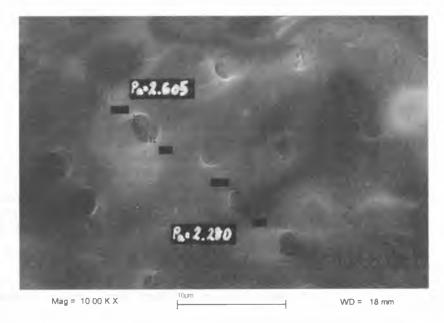
Fig. 7B. Radical dentine of the larger part

The most pronounced changes were observed on the surface of radical dentine of the smaller tooth part, whose structure resembled sclerotic dentine. It was uneven and deprived of tubular lumen (Fig. 7A). One could not distinguish between surfaces, intertubular from peritubular. In the bigger tooth fragment the arrangement of tubules in radical dentine was not so regular. Initial segments of individual tubules had unmineralized dentine. The course of the observed structures was multi-directional. The diameter of tubular lumen ranged from 2.2 to 2.6 μm (Fig. 7B). There was no unevenness within intertubular dentine. In the fusion area at one third of the root length, dentine showed fewer and fewer tubules. Initial segments of tubules had irregular shapes. Tubular lumen was decreased compared with coronal dentine, the diameter of tubules was 1.6 to 2.4 μm . Intertubular dentine was smooth. The dentine of the lower part of the root in the fusion area presented a small number of irregularly distributed tubules. The lumen of a part of those tubules was overgrown. Numerous creases of the intertubular dentine were observed, the majority of which were parallel to the long tooth axis.
